DC-8 NOISE ABATEMENT ENGINEERING COORDINATION MEMO

UNITED AIRLINES

ENGINEERING FLIGHT AND GUEST PILOT EVALUATION REPORT

November 15, 1974

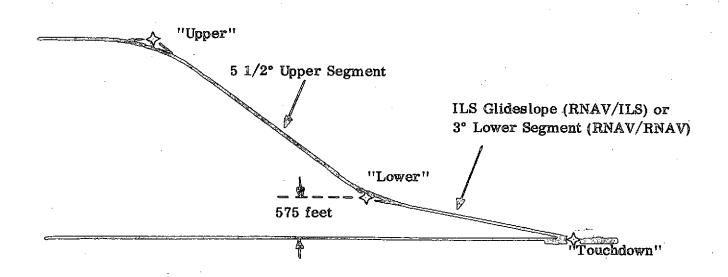
Figure 1
RNAV/Two-Segment Approach Profile for DC-8-61 aircraft

The two-segment profile used throughout the Phase II Engineering Evaluation consisted of a 5 1/2° upper segment which intersected the glideslope or lower segment at 575 feet. This was the optimized profile developed in the Simulation and Phase I Evaluations. The upper segment is defined by two waypoints, "Upper" and "Lower". The lower segment is defined by the ILS glideslope for RNAV/ILS approaches. For RNAV/RNAV approaches the lower segment is a 3° path defined by two waypoints, "Lower" and "Touchdown." (Figure 1)

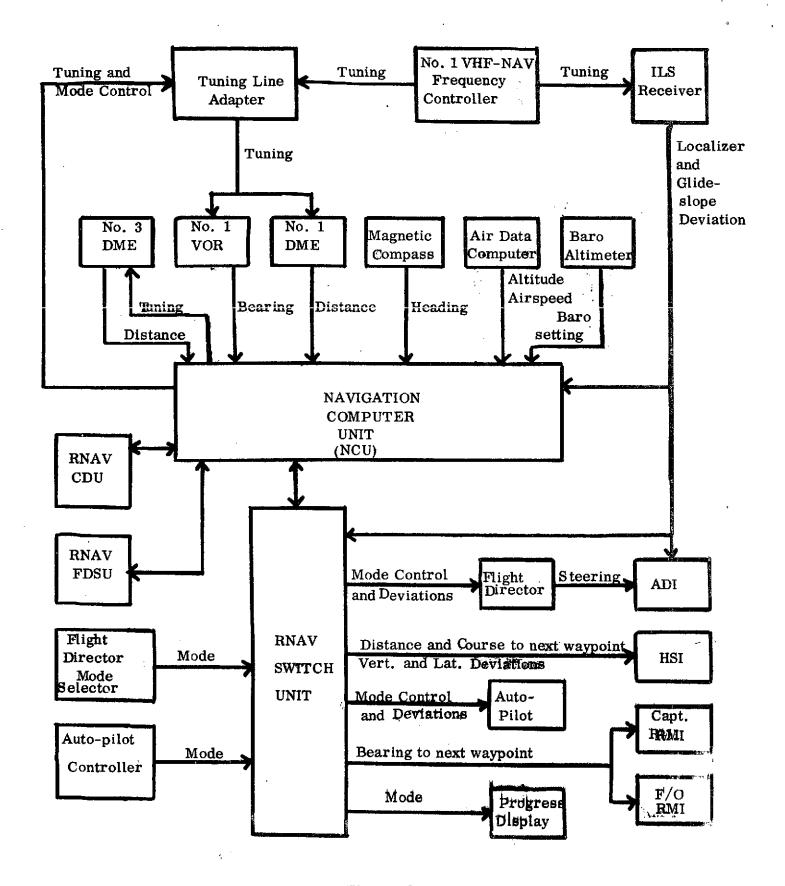
Figure 2 RNAV/Two-Segment Approach System Interface Diagram

To permit full utilization of the RNAV system and to provide all required display furnitive certain modifications and additions to the standard aircraft equipment complement were necessary. Figure 2 is a simplified system interface diagram. The Captain's VOR receiver was modified to provide sine and cosine station bearing outputs for use by the RNAV computer. The Captain's existing ARINC 521 DME interrogator was replaced with an ARINC 568 DME to permit the RNAV computer to tune it with ARINC 2X5 control lines, and to provide a distance readout compatible with the RNAV computer input. An additional DME interrogator was added to enable the RNAV system to obtain DME-DME position fixes. The Horizontal Situation Indicator (HSI) was replaced with a new unit with two distance displays (one for RNAV computed distance to waypoint). The course knob on this special unit served as the master RNAV engage switch. The Attitude Director

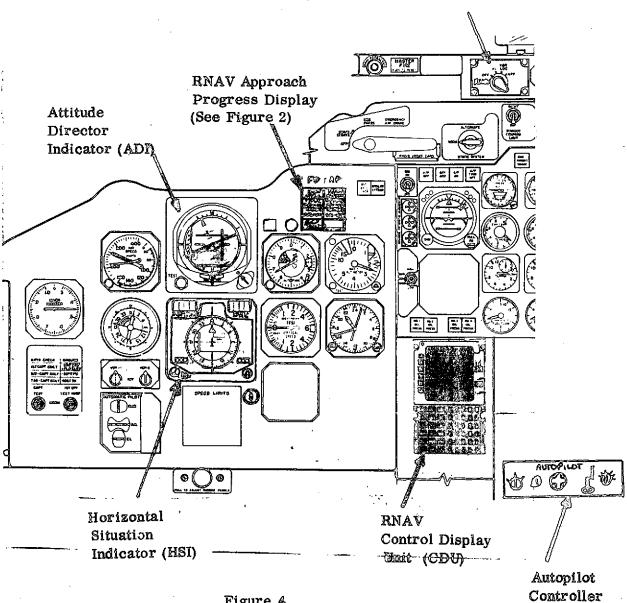
Figure 4 CAPTAIN'S INSTRUMENT PANEL

The RNAV system interfaces only with the Captain's sensors and displays, (Fig. 4). All normal aircraft system functions are available when the RNAV system is not in use. When the RNAV system is engaged, by pushing in the course knob on the Captain's HSI following actions occur.

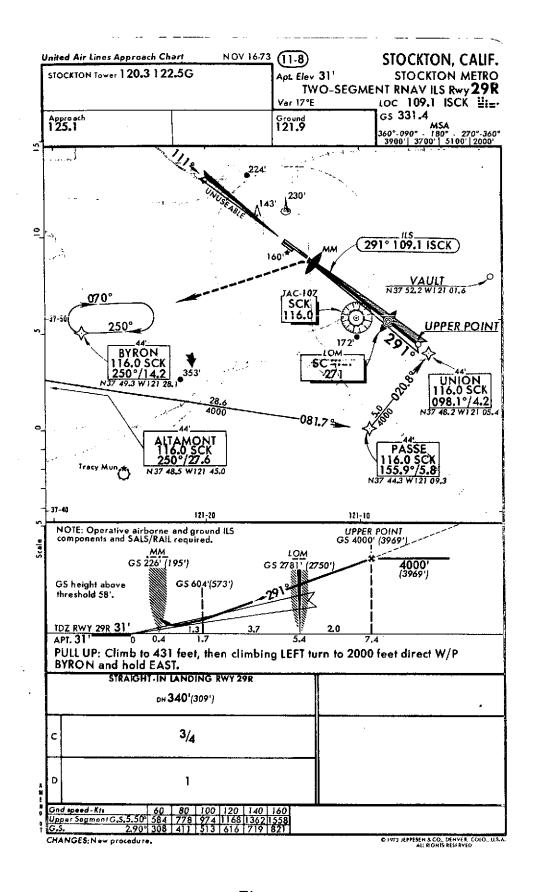
Figure 5
Typical RNAV/Two-Segment Approach Reference Chart
(For Illustration Only - Not to be used for Navigation Purposes)
Reprinted by Permission

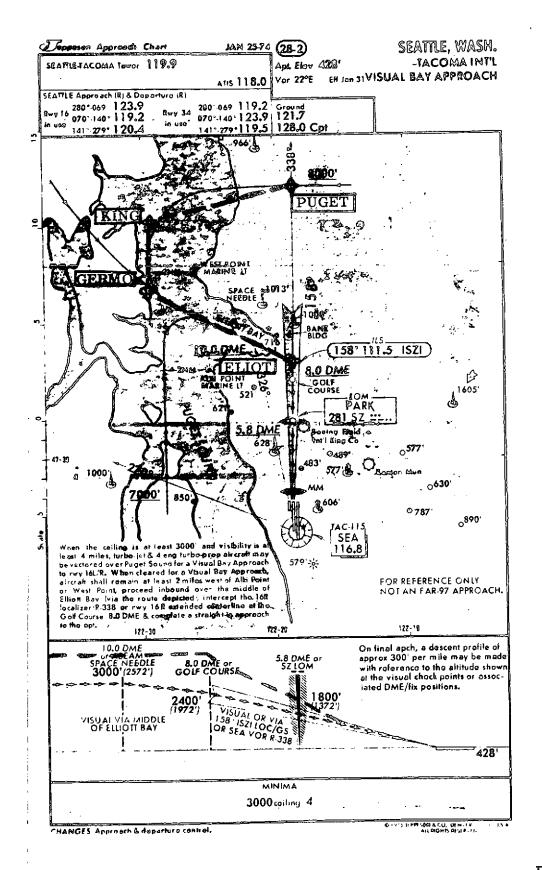
RNAV ELLIOTT BAY AND TWO-SEGMENT APPROACH PROCEDURE (DASHED LINES) SUPERIMPOSED ON VISUAL BAY APPROACH PROCEDURE

During the approaches to Seattle runway 16, an RNAV procedure was used which closely followed the existing "Visual Bay Approach" presently used in visual conditions to provide noise abatement to the city of Seattle. These approaches demonstrated the applicability of RNAV systems to provide <u>lateral</u> approach path guidance for noise abatement. Details are provided in Appendix D.

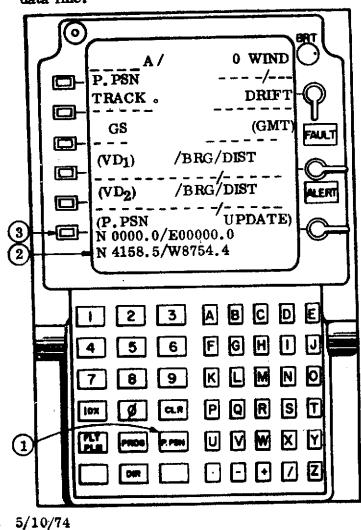
- 1. Press the P.PSN (Present Position) key on the CDU.
- 2. Using the Alpha Numeric Keyboard, type the station (Ramp) coordinates on the CDU scratch pad. This information is found on pages 414.3 and 414.4 of the Flight Operations Manual, and for selected airports in Attachment #1. (ORD shown in example)
- 3. Press the LINE KEY adjacent to (P.PSN UPDATE) to transfer coordinates from the scratch pad to the data line.

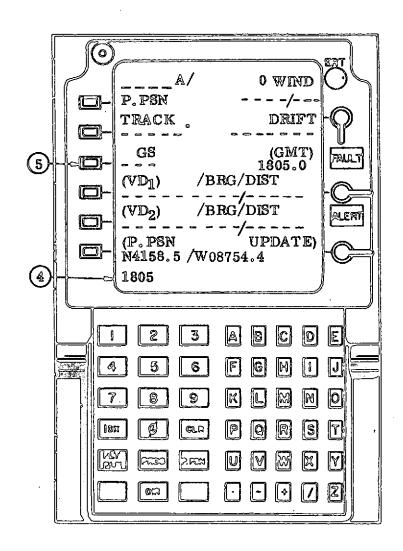
- 4. Type the current GMT time on the scratch pad.
- 5. Press the LINE KEY adjacent to the GS & (GMT) line to enter the time into the computer.

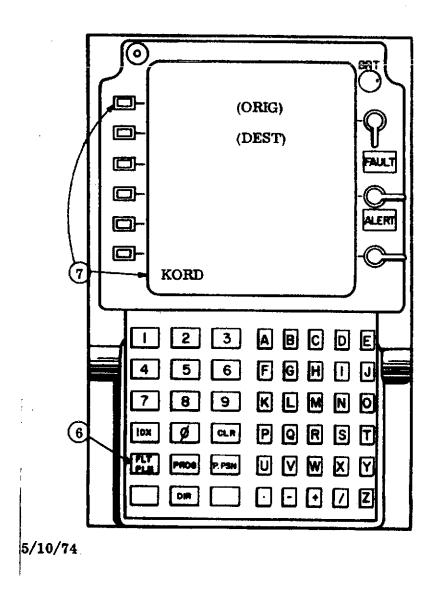
- 6. Press the Flight Plan Key FLT (ORIG) & (DEST) will appear on the CDU.
 - 7. Enter the origin airport by typing the airport designation on the scratch pad (i.e., KORD) and then press the LINE KEY adjacent to (ORIG).

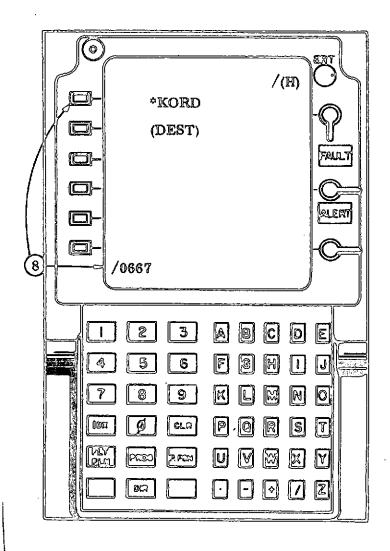
8. Enter the origin airport field elevation by typing the elevation on the scratch pad (i.e., /0667) and then press the LINE KEY adjacent to KORD on the CDU.

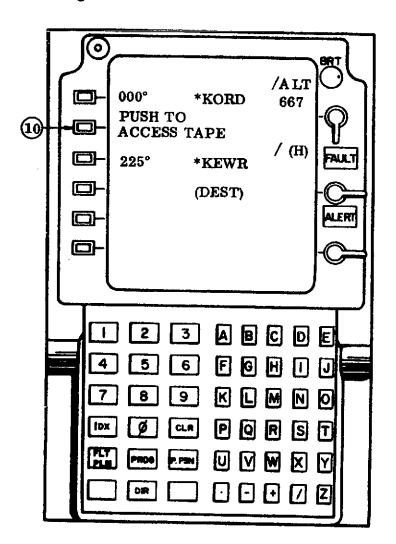
- 9. Enter the destination airport by typing the airport designation on the scratch pad (i.e., KEWR) and then press the LINE KEY adjacent to (DEST).
- 10. A message "PUSH TO ACCESS TAPE" will appear between the origin & destination airports. Push the LINE KEY adjacent to the message.

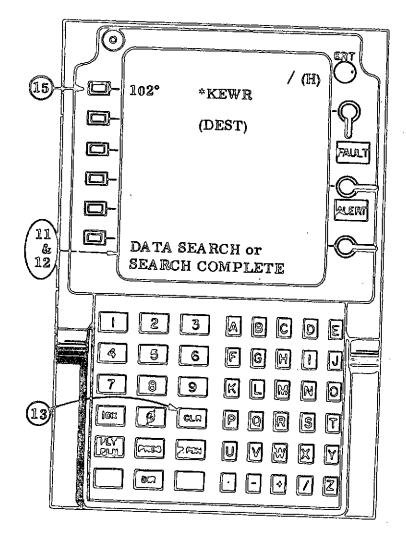
- 11. A message "DATA SEARCH" will now appear on the CDU while the tape is being read by the NCU.
- 12. When the search is completed, a message "SEARCH COMPLETE" will flash on the scratch pad.
- 13. Press the CLR key to remove this message from the scratch pad.

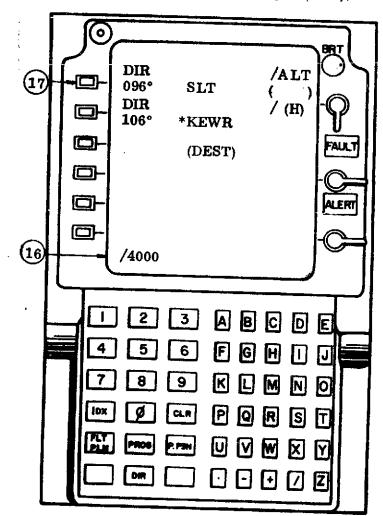
- 14. Type the Update Waypoint (i.e., SLT) on the scratch pad.
- 15. Insert the Update Waypoint ahead of the destination by pressing the LINE KEY adjacent to the destination airport (KEWR). (See page 6)
- 16. Edit the Update Waypoint altitude by entering the initial approach altitude at the destination.
 Write the altitude on the scratch pad (i.e., /4000).

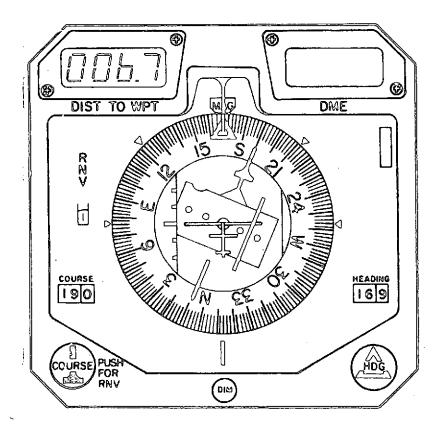
Course Indicator (CI)

- 18. To test the RNAV engage and autotune function:
 - 1. Push in the CI course select knob and check that right hand DME readout goes blank and numerals appear in upper left hand readout for DIST TO WYPT. The GREEN Autotune light located next to the #1 VHF NAV selector will illuminate.
 - Pull course knob out and see that left readout goes blank and right hand DME is illuminated.
 The Autotune light should go out.

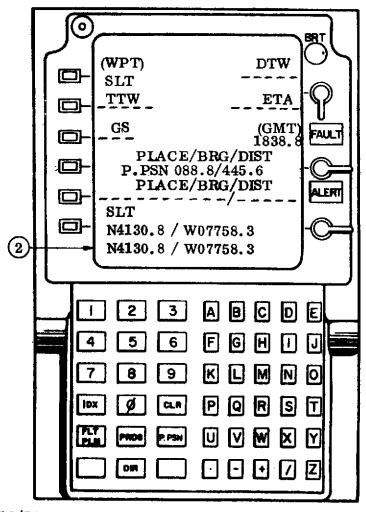
2. Copy the LAT/LONG from the Waypoint page onto the scratch pad.

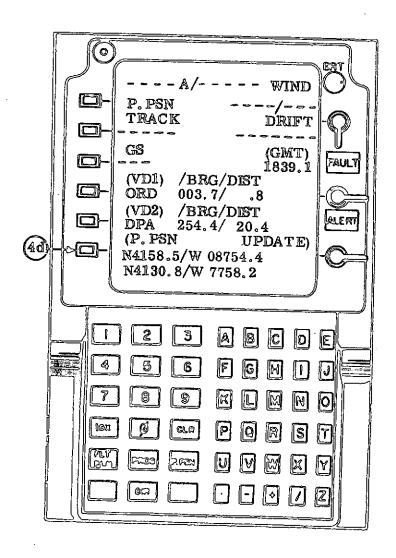
3. Select P. PSN page and observe indicated P. PSN LAT/LONG just above the LAT/LONG written in the scratch pad.

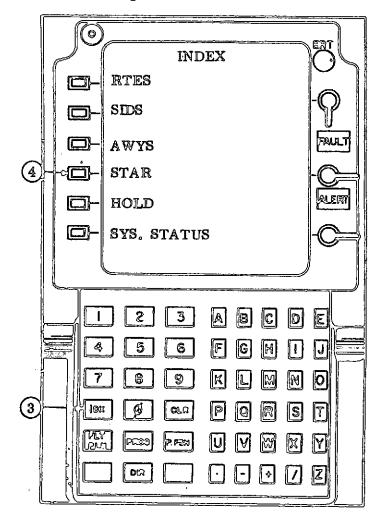
- 1. After obtaining the ATIS, determine if you intend to fly a Two-Segment Approach and if it will be an RNAV/ILS or RNAV/RNAV.
- 2. Advise ATC of your intentions.
- 3. Select IDX, index page, on the CDU.
- 4. Press the LINE KEY adjacent to STAR to select the STAR page.

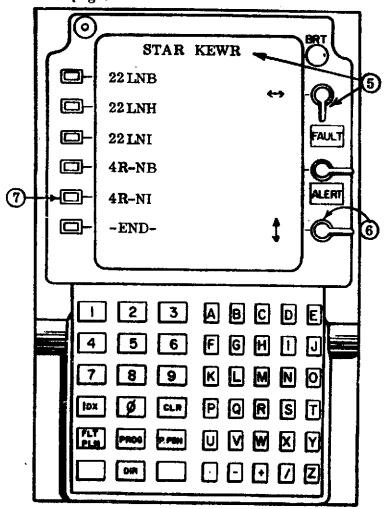
7. Press the LINE KEY adjacent to the desired approach (4R-NI). The approach will appear on the scratch pad and the CDU will automatically switch to the Flight Plan page.

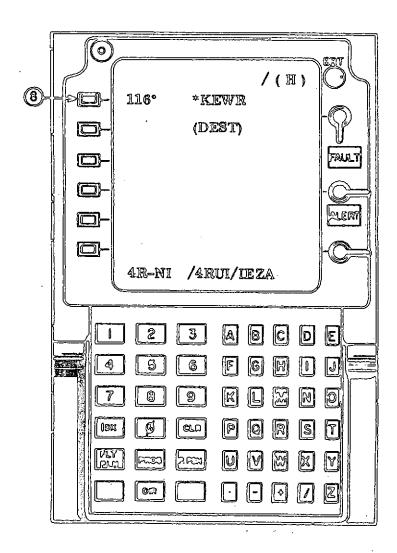
The CDU screen will indicate UPPER, LOWER, TOUCHDOWN RUNWAY END (TD4R), DEPARTURE RUNWAY END (RW22L).

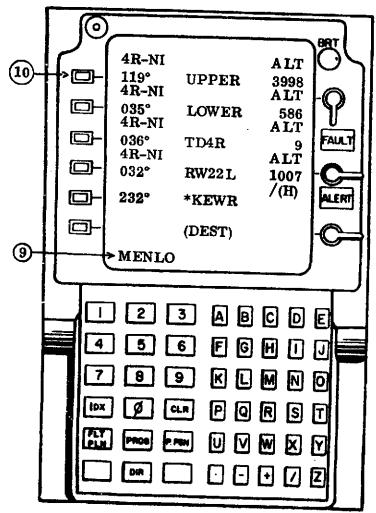
10. Enter the waypoint by pressing the LINE KEY adjacent to UPPER.

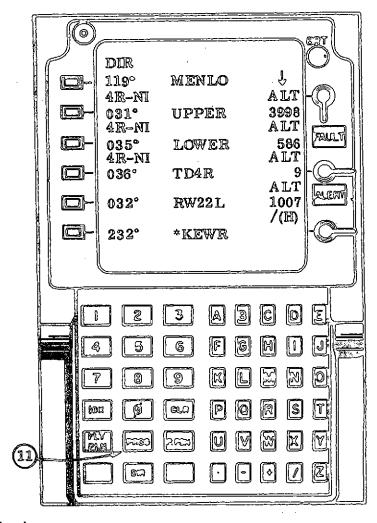
11. Select PRCG page on the CDU.

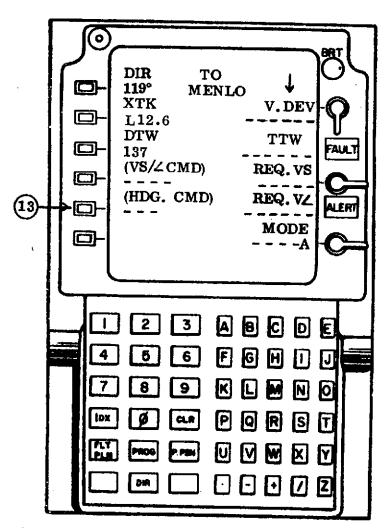
- 12. Write the initial approach altitude on the scratch pad (i. e. /4000) and enter it at the "TO" waypoint by pressing the top LINE KEY.
- 13. Select heading command by pressing the LINE KEY adjacent to (HDG. CMD). (5th LINE KEY from the top)

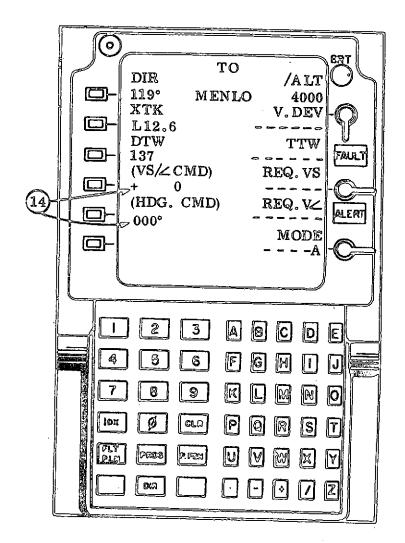
14. The present airplane heading will appear under (HDG. CMD) and the present airplane vertical speed will appear under (VS/LCMD).

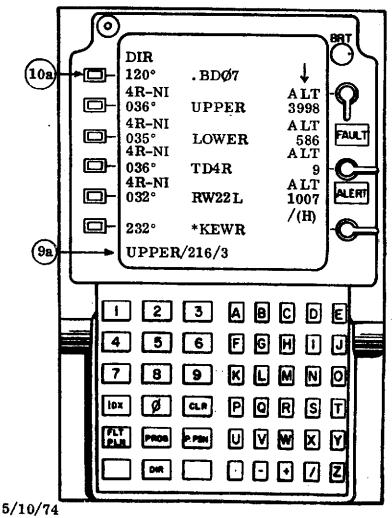
Write on the scratch pad UPPER/216° (the reciprocal of the inbound course)/3 (the distance you want to create the waypoint from UPPER). This defines a waypoint by bearing 216° and distance 3 miles from UPPER. The computer will assign a BD identification to this waypoint.

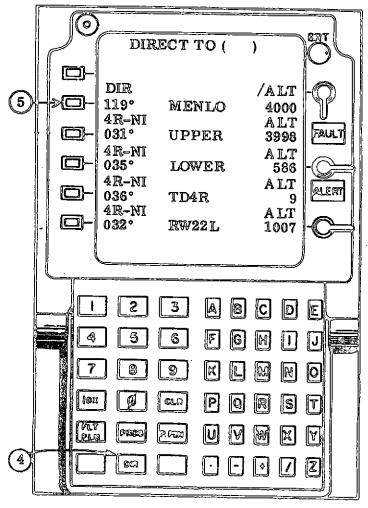
4. When on the final intercept heading and cleared for the approach, press the DIR key. The CDU will change from the PRCG page to the FLT PLN page and DIRECT TO () will appear at the top of the CDU.

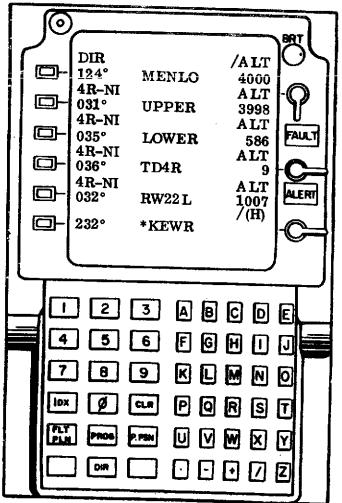
- 6. The DIRECT TO page on the CDU will change to the FLT PLN page and the "TO" waypoint will be at the top of the CDU.
- Move the F/D Mode Selector to the RNAV Position and follow the command bars for the approach or;

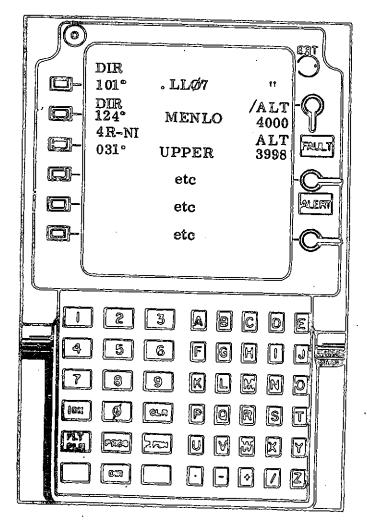
This will appear on the CDU as shown below.

The LL number is assigned by the computer.
